# COILWORLD

Vol 18 | Issue 2

# Tale of Two Coil Coaters— Five Years Later

## Long Upgrade Commitment Boosts Coil Coater's Capabilities

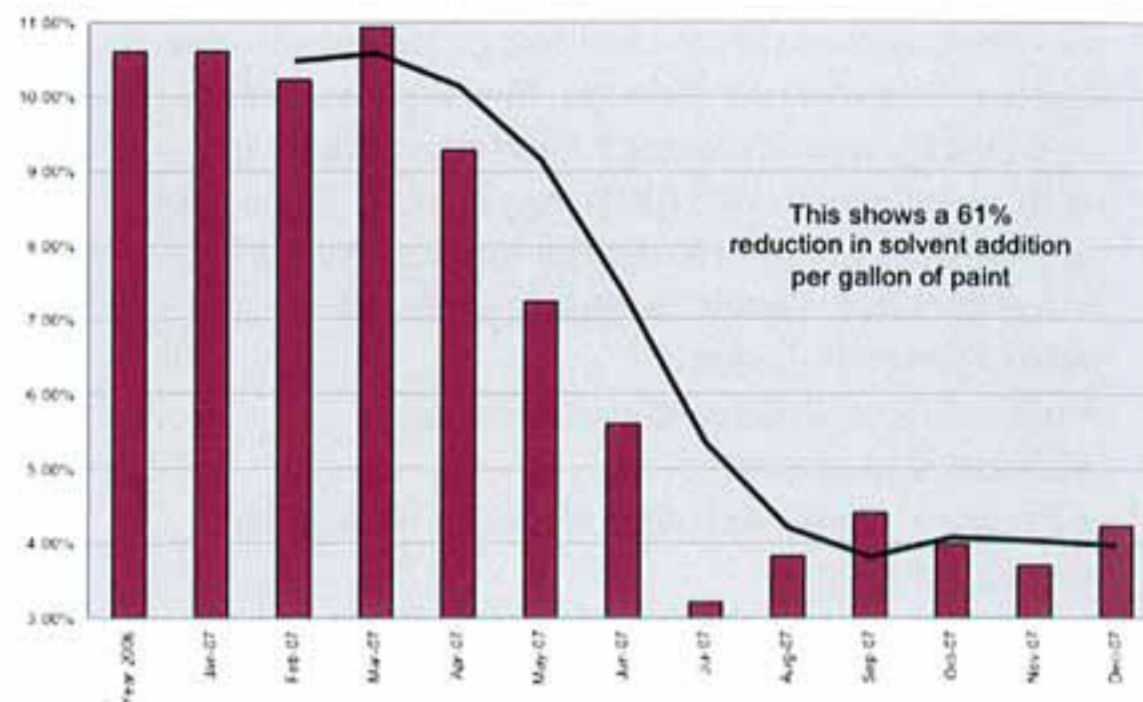
Figure 1: Percent Solvent Added per Gallon of Paint

- Reduced paint consumption decreased the number of paint shortages caused by exceeding estimated usage
- Reductions in solvent additions in excess of 60%, (shown in Figure 1) resulted in significant cost savings for 2007 over 2006.

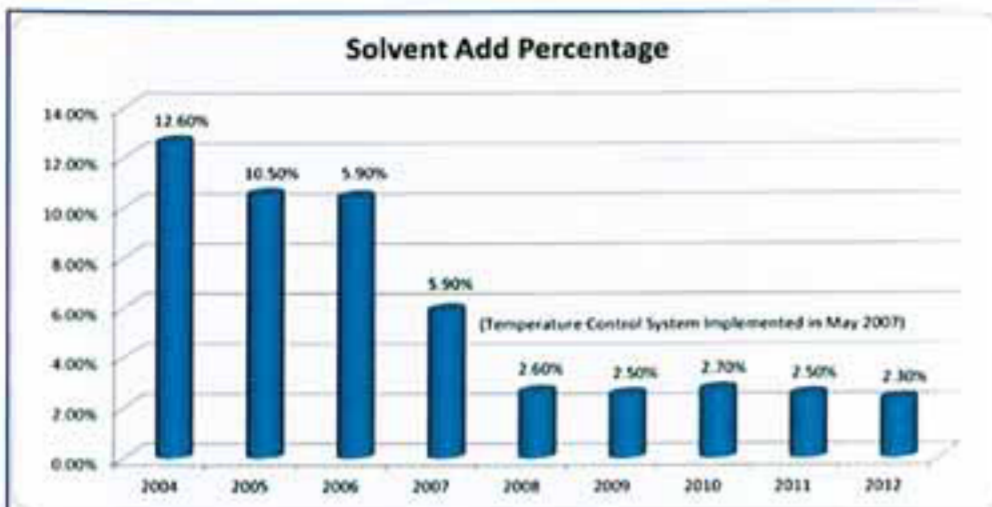
**Figure 2: Percent Solvent Added per Gallon of Paint**

From its inception, one of the key factors in this implementation was the system's ability to control reducing solvent consumption. Solvent costs were as high as \$11.00/gallon when the system was installed, and these same solvents now exceed \$13.00/gallon! The team originally set a target to reduce solvent additions by 50%. As shown in the recap above, during the first few months of operation, solvent addition for viscosity adjustment was reduced by 61% from an average of 10.5% to around 4%. Continuous improvement in the process since that time has resulted in further reductions, with solvent addition now at around 2.3%, bringing the total reduction to more than 75%. As *Figure 2* shows, this has become the "new normal" over the last five years.

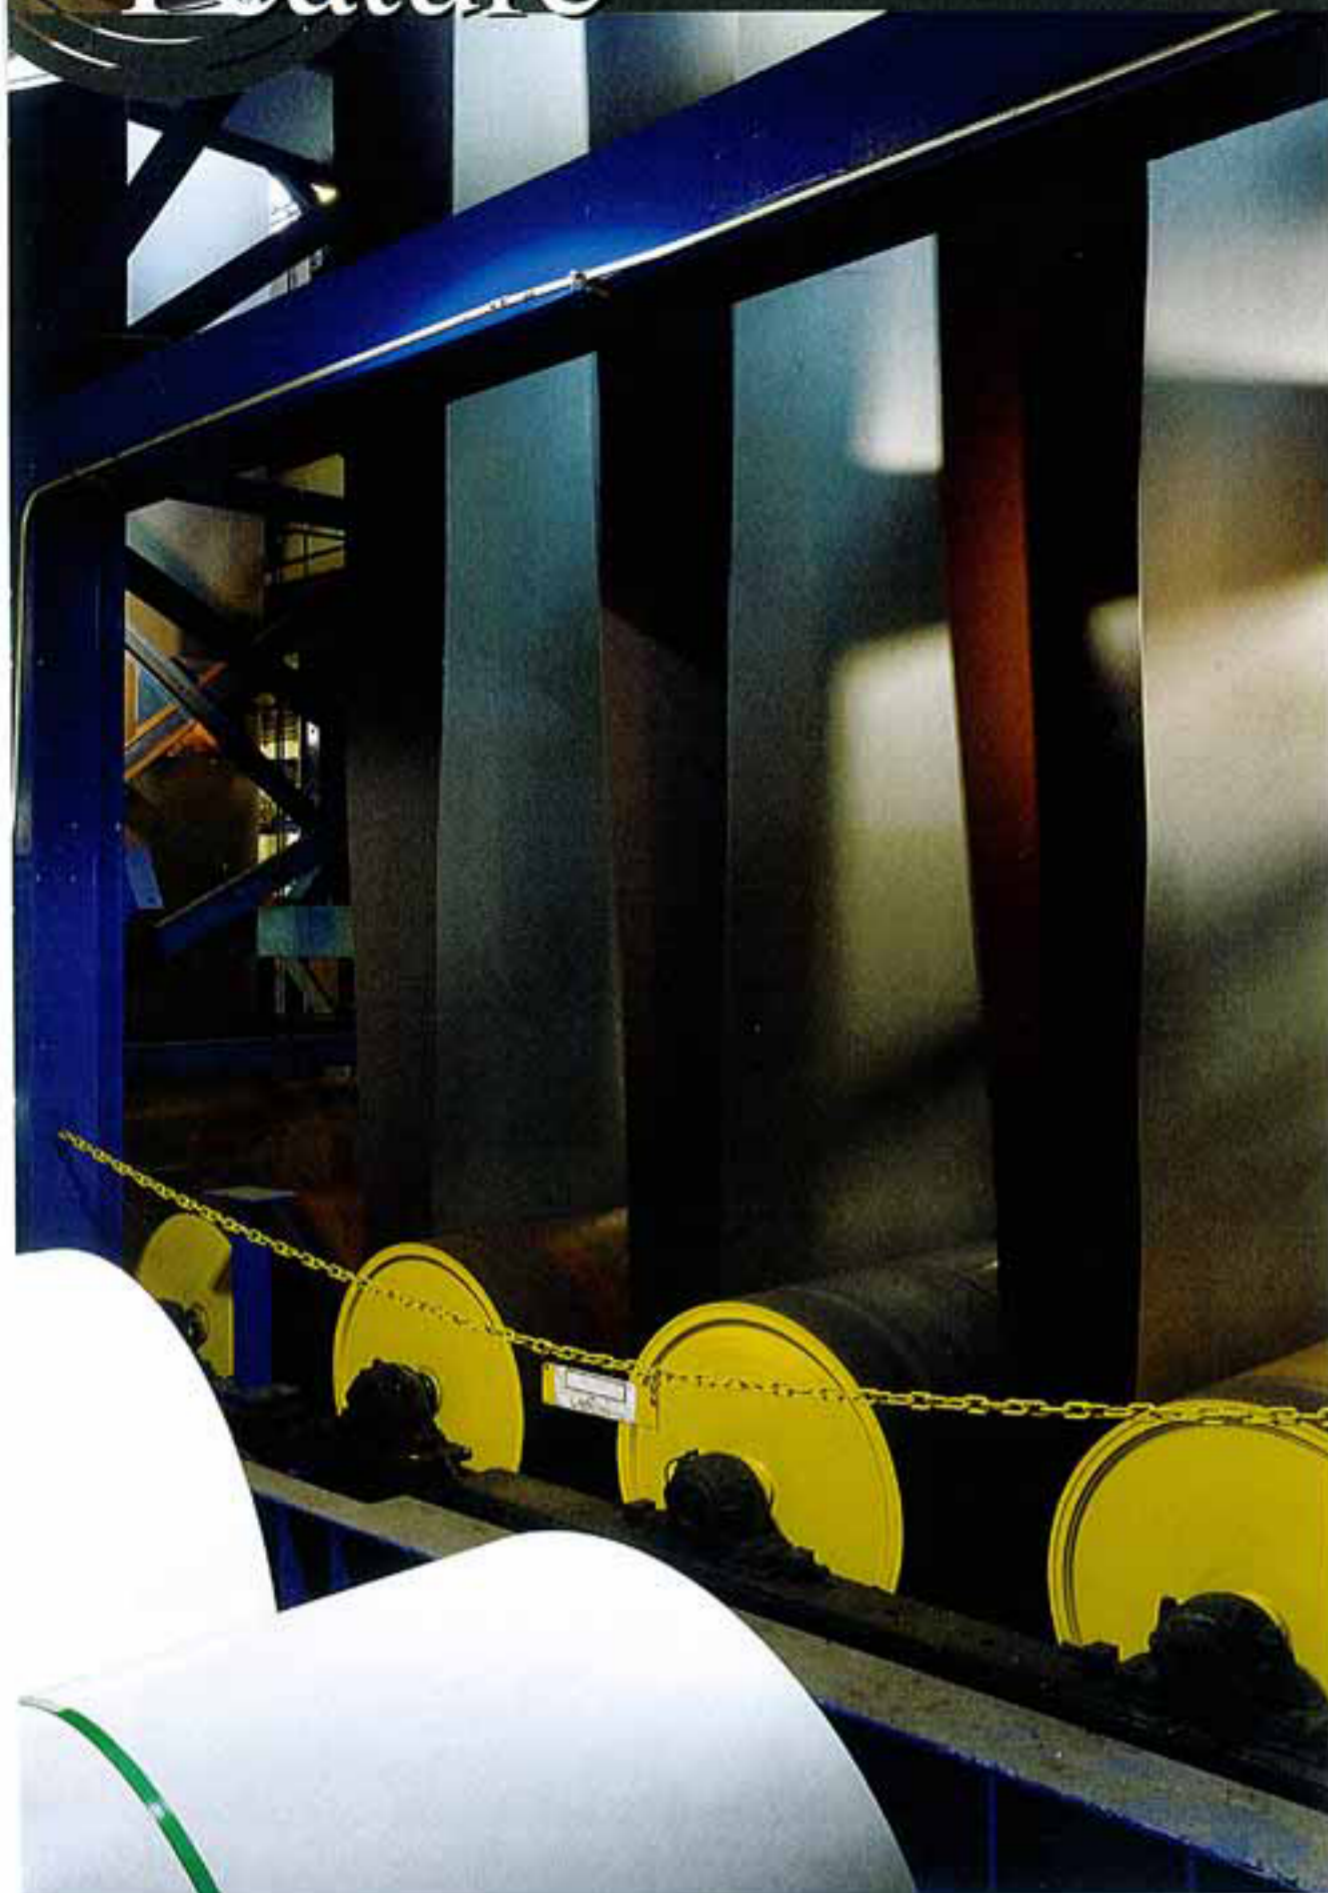
As part of Centria's Ambridge facility retrofit project was the upgrade of its accumulator tower.

Other major changes include upgrades to the finish and prime coater ovens, steering system, and accumulator tower. In addition, Ambridge has added a new off-line embosser. Previously, the plant only had an embosser in-line with the paint line. With this new investment, the plant can emboss a wider range of products and has improved the product quality and flatness.

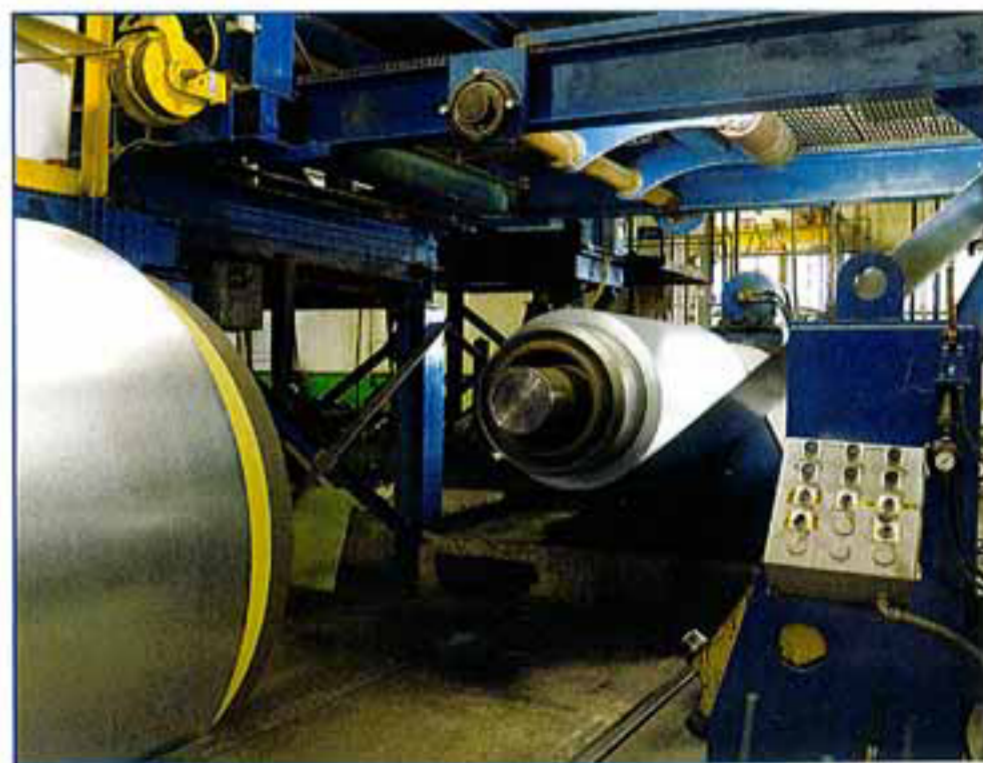
A metal strip moves onto the recoiler prior to the coil being prepared for packaging.

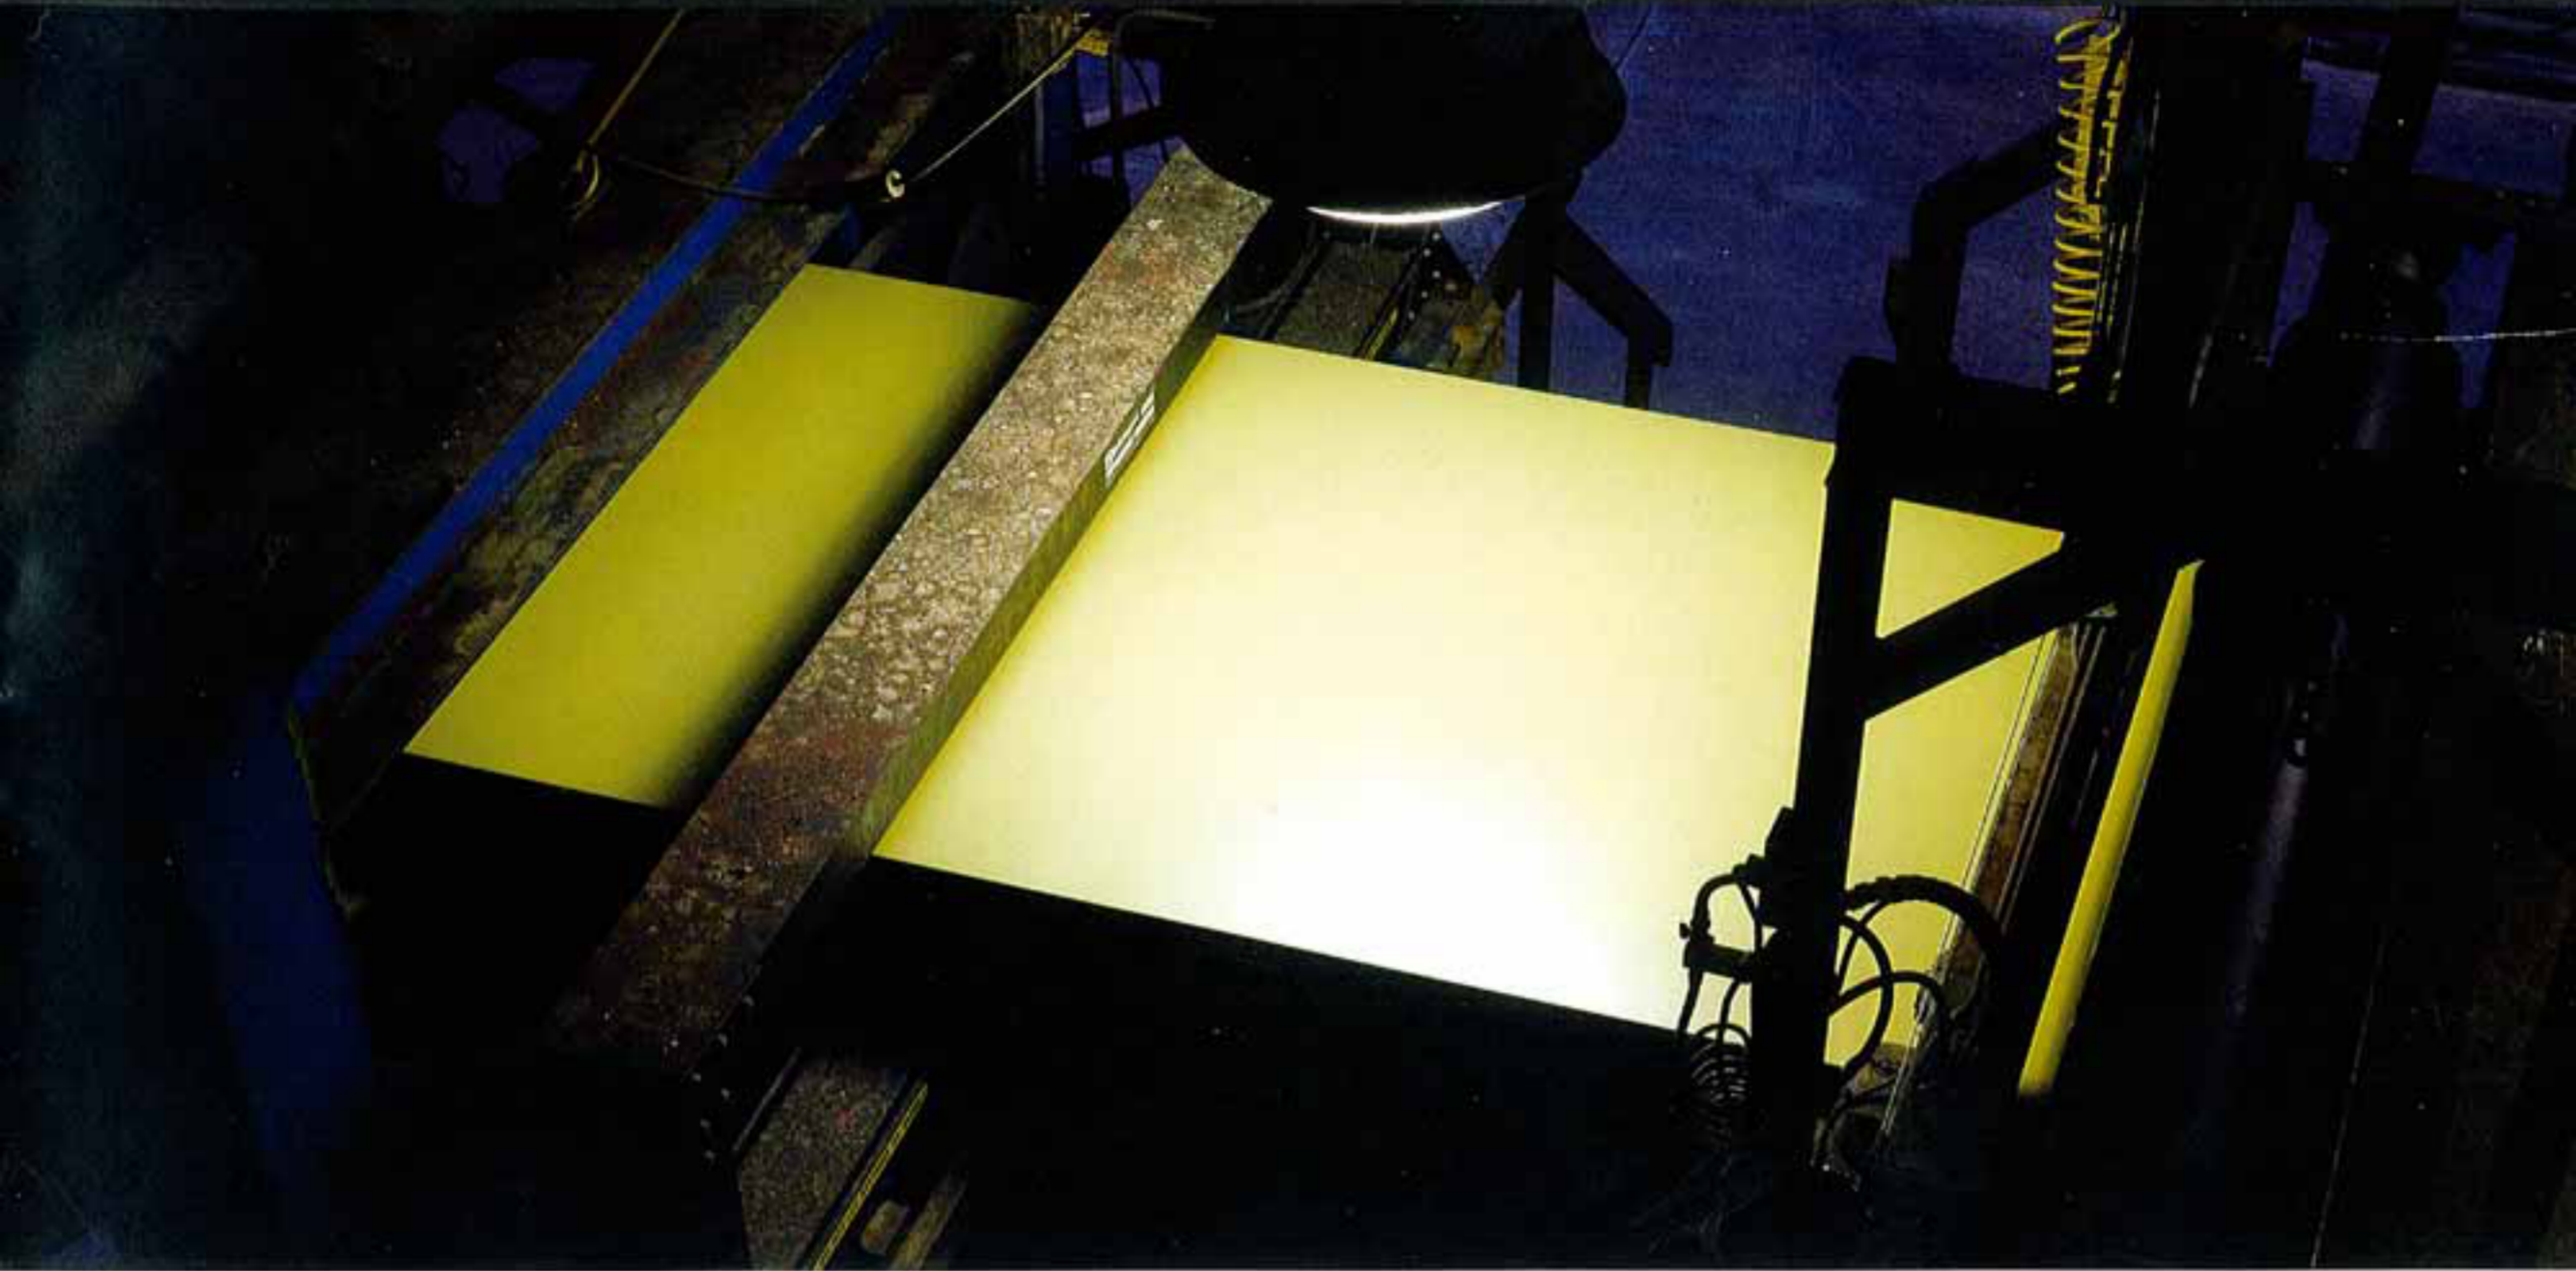
A painted strip passes under inspection lights where it is checked for defects.
